# Property Screening Report

6570 Caicos Court, Vero Beach, FL 32967

FL05-0208

RE: Chinese Drywall Screening Report Number FL05-0208  
Property Located at: 6570 Caicos Court, Vero Beach, FL 32967

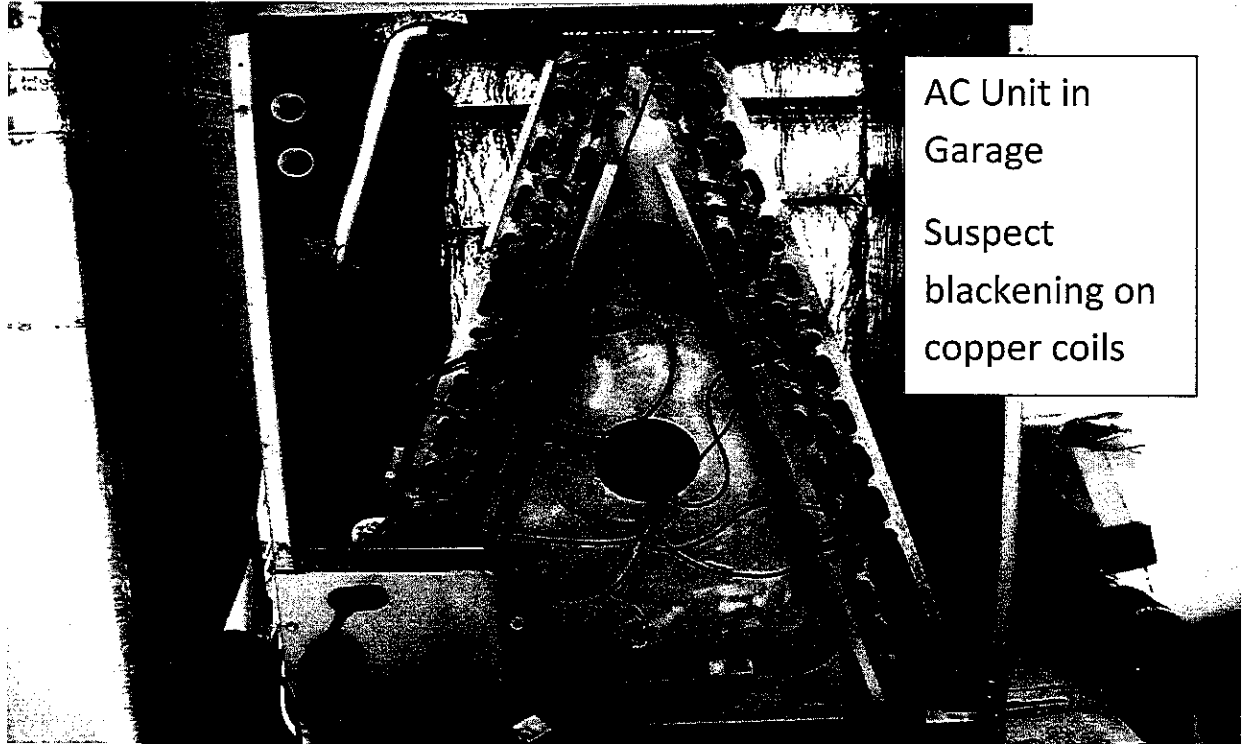
AC Unit in  
Garage

Soot or "black deposits" as defined by Unified Engineering File No. 4050 associated with reactive drywall were not observed on the AC evaporator coils except for some suspect areas. Soot was not observed on the external refrigerant line. Ground and primary wires of the electrical panel had no residue. The water heater is in the garage and the piping had no soot residue. Fixtures in the bathrooms had no corrosive spotting. Desilvering and halos were not observed on mirrors. Soot was not observed on ground wires of inspected receptacles and switches throughout the home. National Gypsum drywall label was observed in Garage and Interior Ceiling from Attic. The copper dishwasher water supply line was dark, however, the Client stated that there was an extended leak from the garbage disposal, which caused this darkening on the water supply line. The receptacle directly behind the water supply line had no soot residue.

Suspect  
blackening on  
copper coils

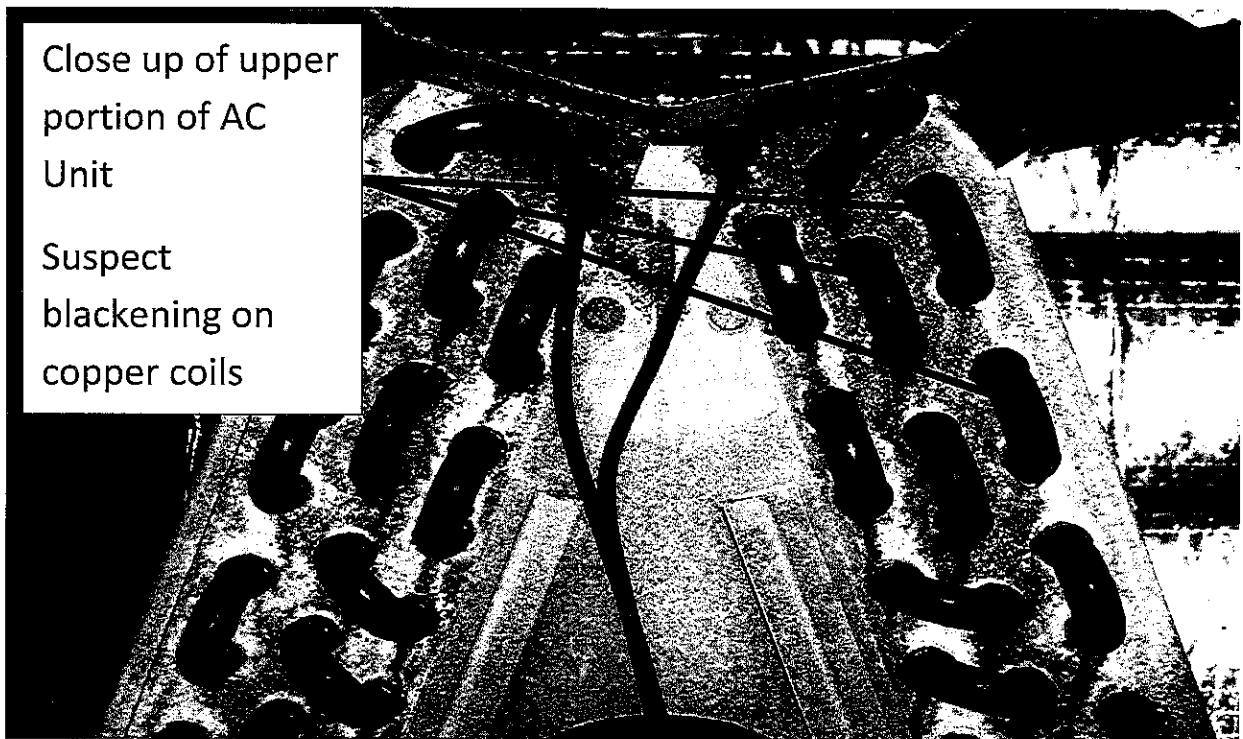
Close up of upper  
portion of AC  
Unit

Suspect  
blackening on  
copper coils

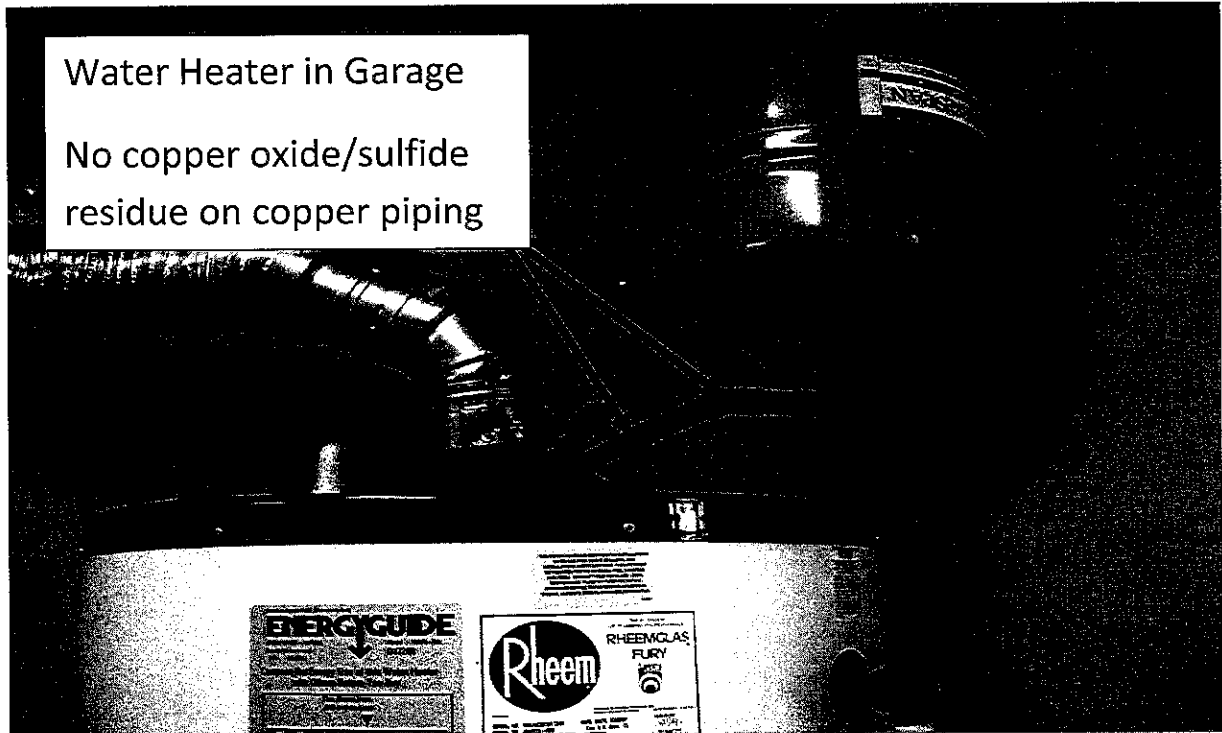
Water Heater in Garage  
No copper oxide/sulfide residue on copper piping

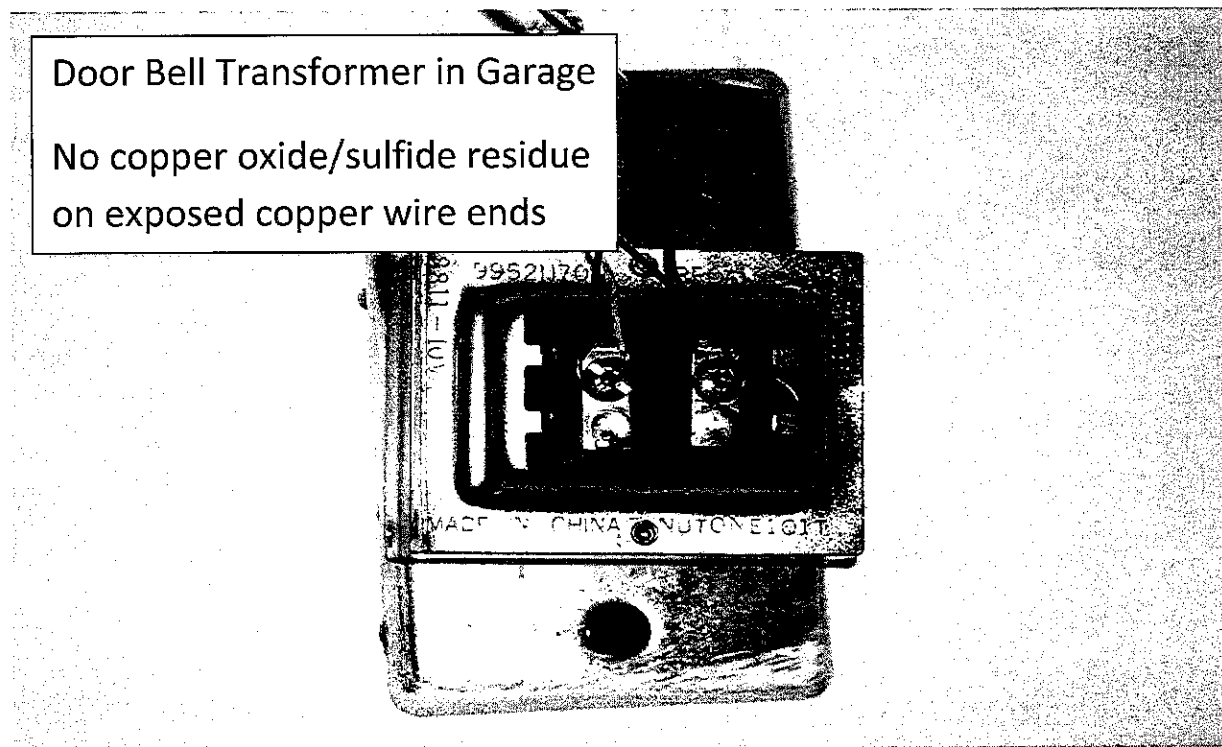
Door Bell Transformer in Garage  
No copper oxide/sulfide residue on exposed copper wire ends

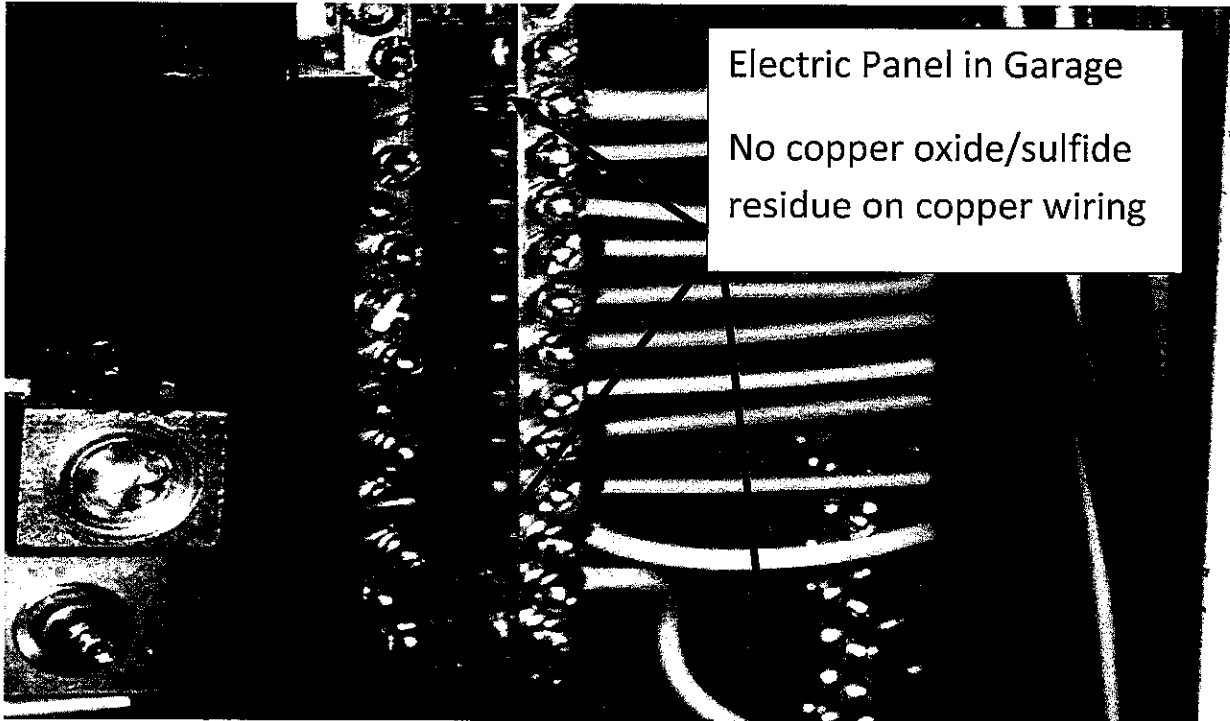
Electric Panel in Garage  
No copper oxide/sulfide residue on copper wiring

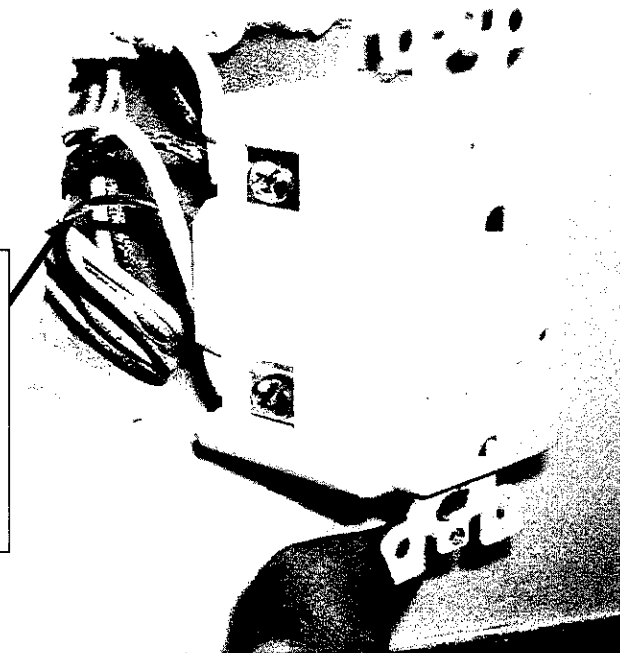
Kitchen Receptacle, West wall

No copper oxide/sulfide residue on copper ground wire

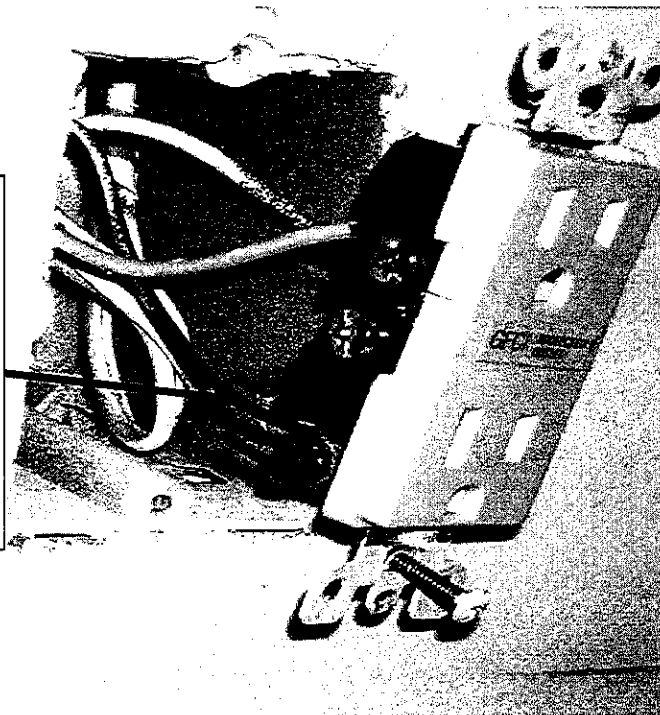
Dining Room Receptacle,  
East wall

No copper oxide/sulfide  
residue on copper ground  
wire

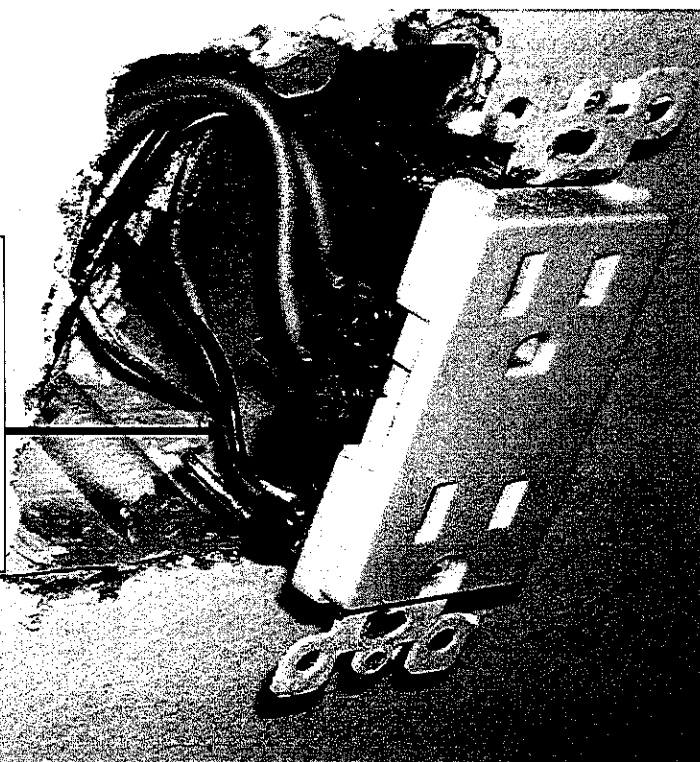
Dining Room Receptacle,  
West wall

No copper oxide/sulfide  
residue on copper ground  
wire

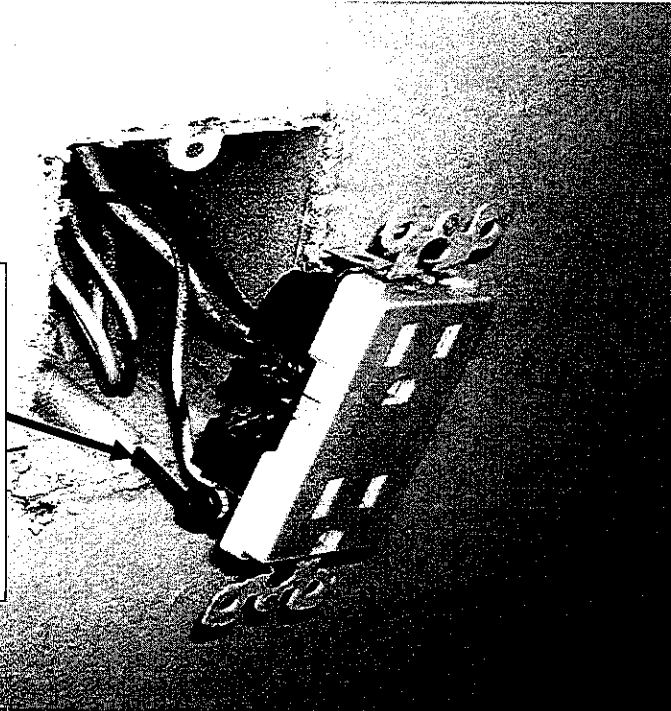
Den Receptacle, South wall

No copper oxide/sulfide  
residue on copper ground  
wire

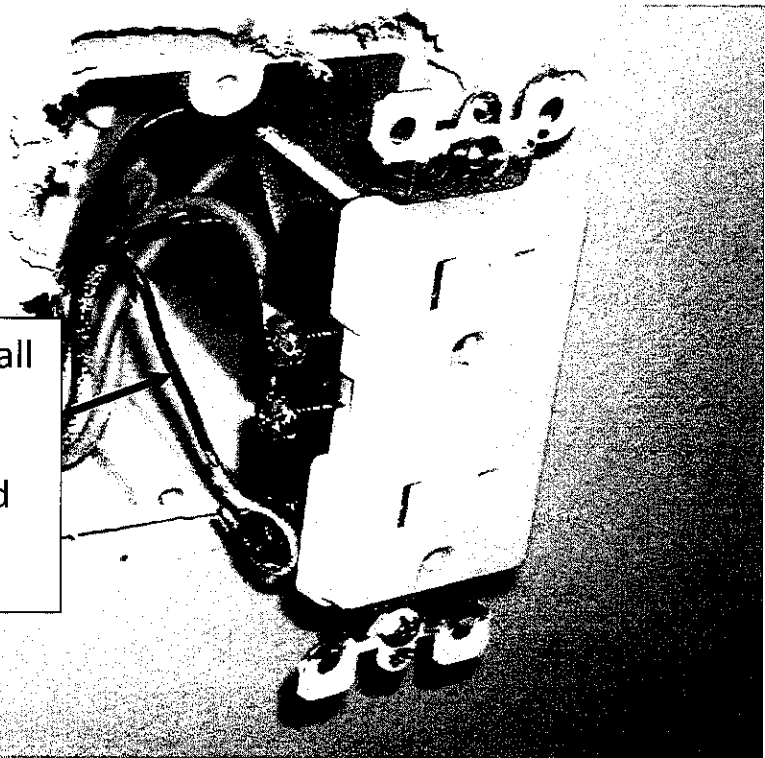
Foyer Receptacle, South wall

No copper oxide/sulfide residue on copper ground wire

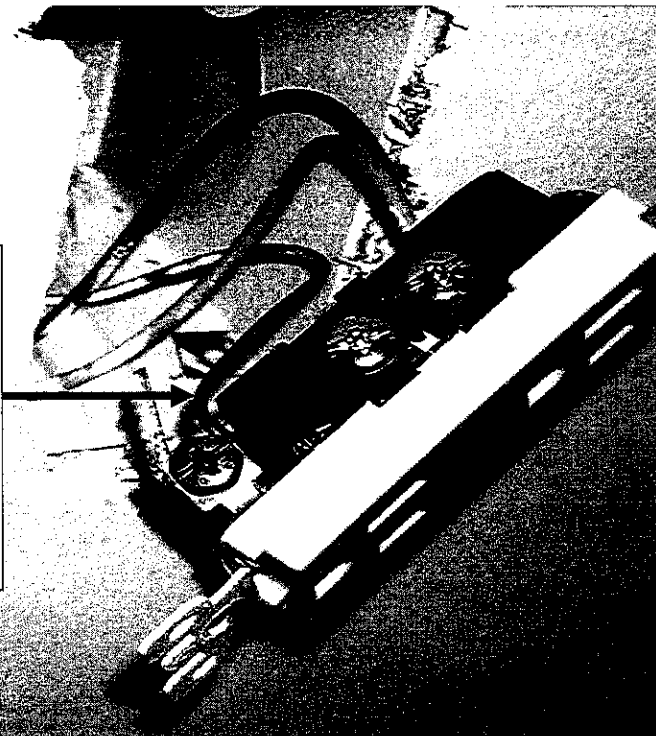
Great Room Receptacle, North wall

No copper oxide/sulfide residue on copper ground wire

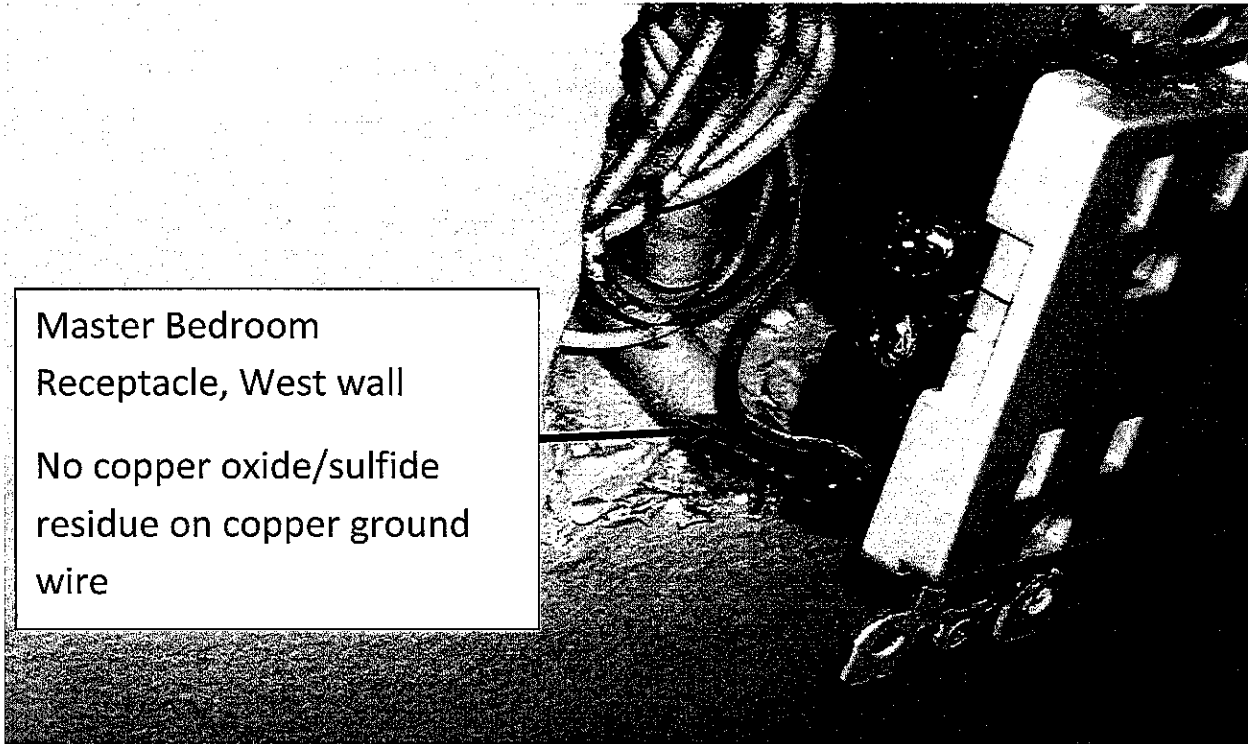
Master Bedroom  
Receptacle, West wall

No copper oxide/sulfide  
residue on copper ground  
wire

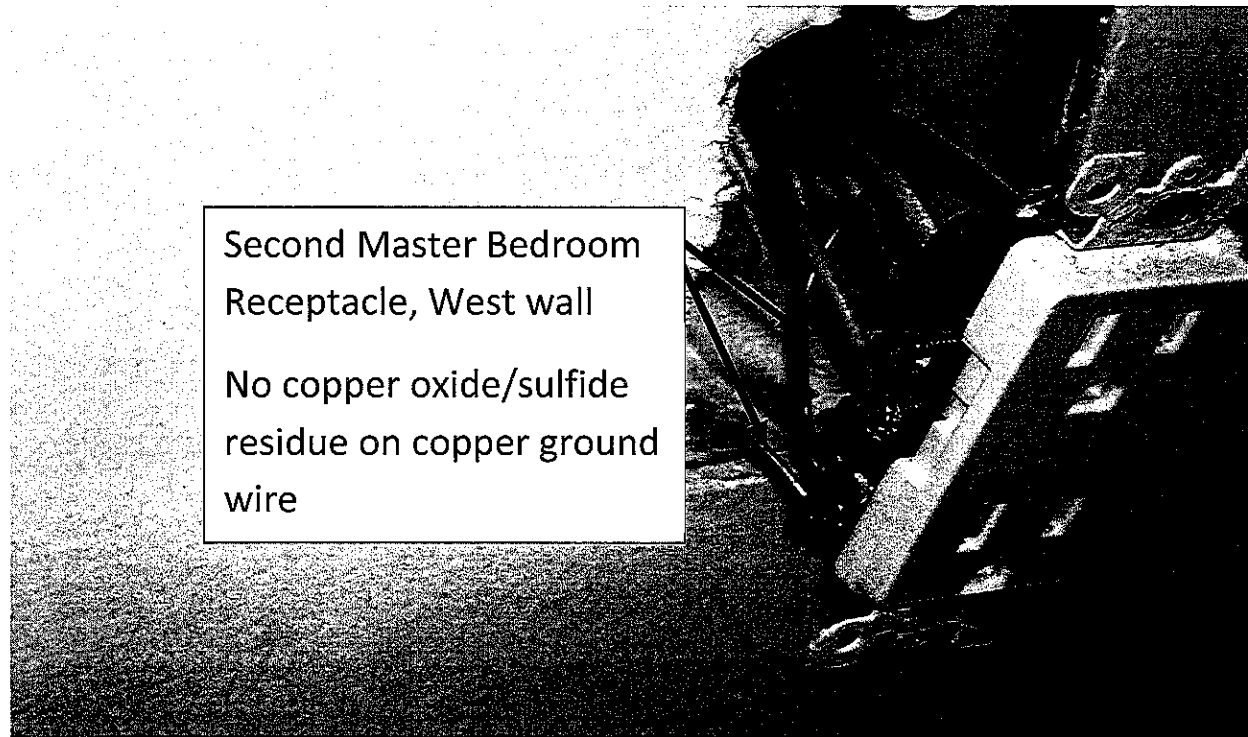
Second Master Bedroom  
Receptacle, West wall

No copper oxide/sulfide  
residue on copper ground  
wire

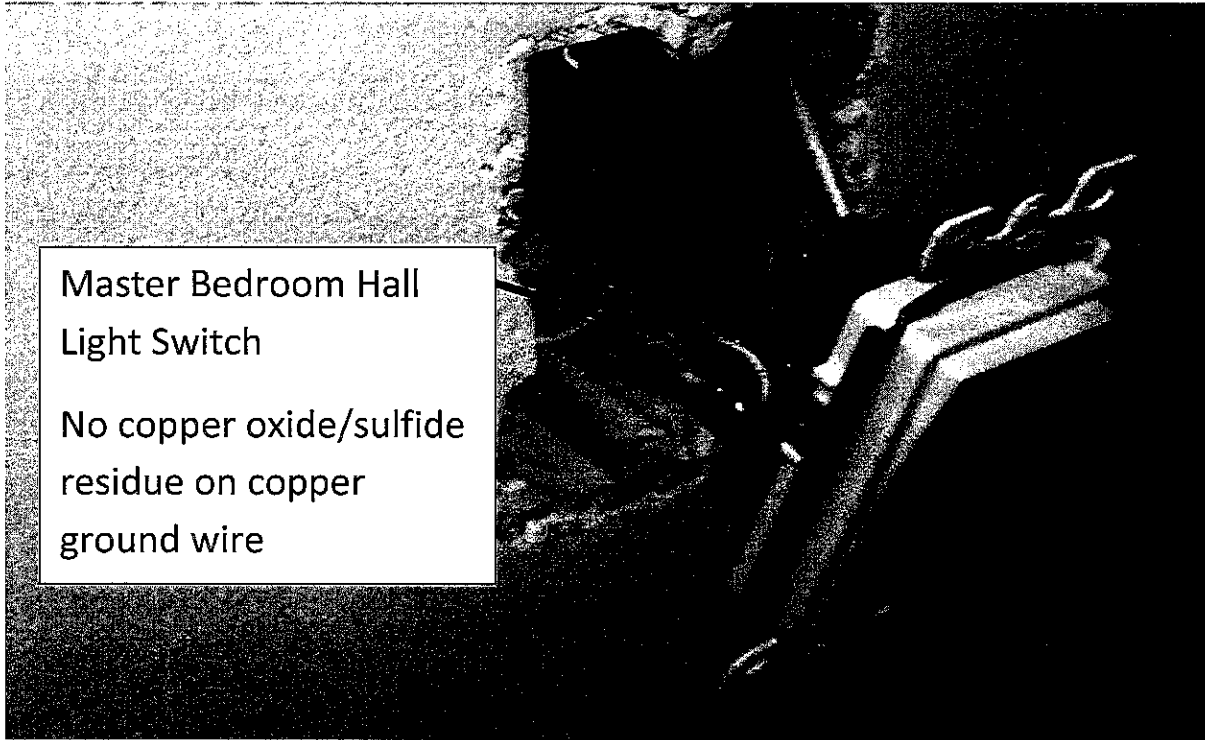
Master Bedroom Hall  
Light Switch  
No copper oxide/sulfide  
residue on copper  
ground wire

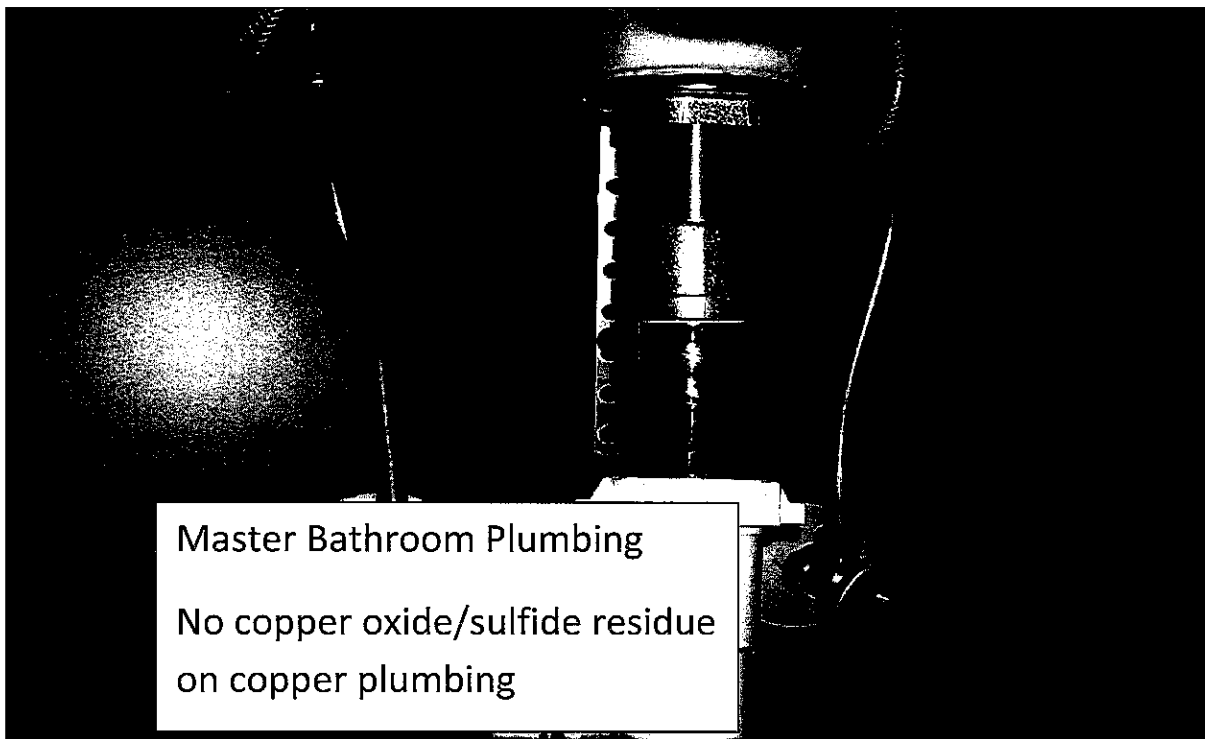
Master Bathroom Plumbing  
No copper oxide/sulfide residue  
on copper plumbing

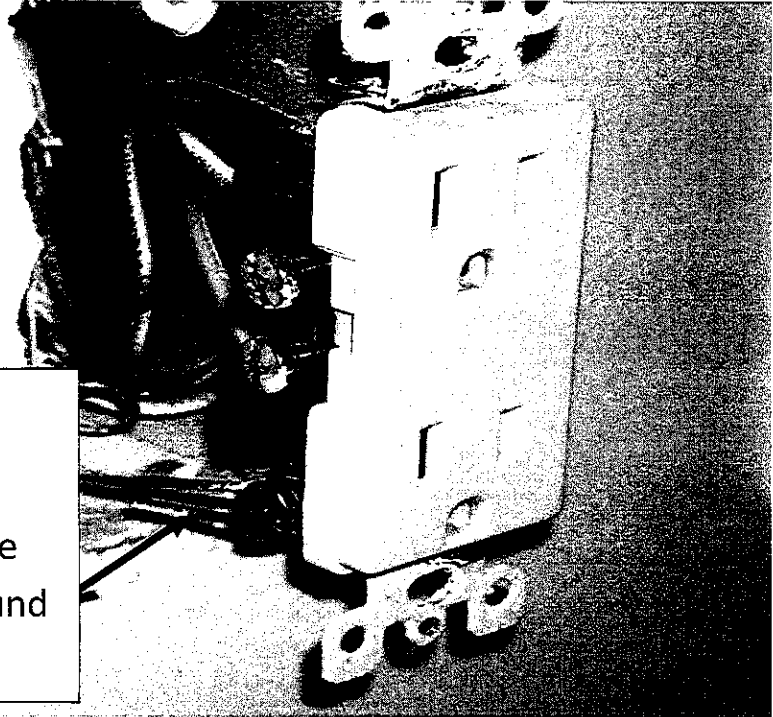
Guest Bedroom 3 Hall to  
Laundry Room Receptacle  
No copper oxide/sulfide  
residue on copper ground  
wire

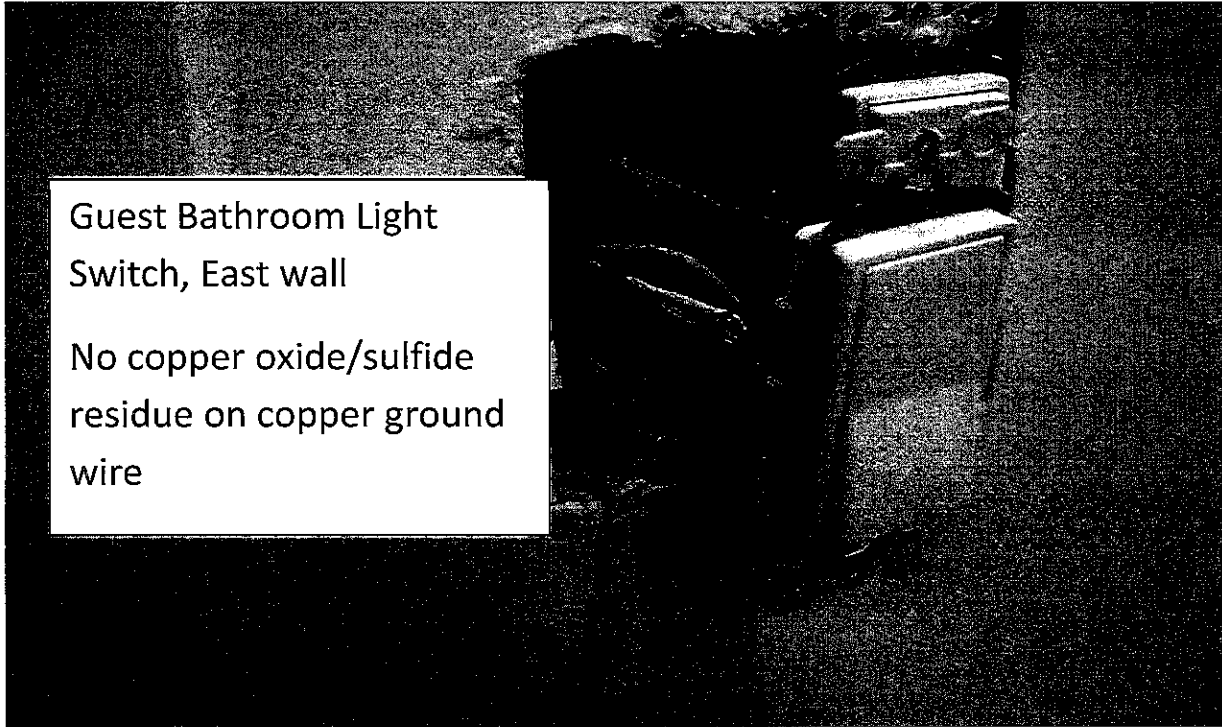
Guest Bathroom Light Switch, East wall  
No copper oxide/sulfide residue on copper ground wire

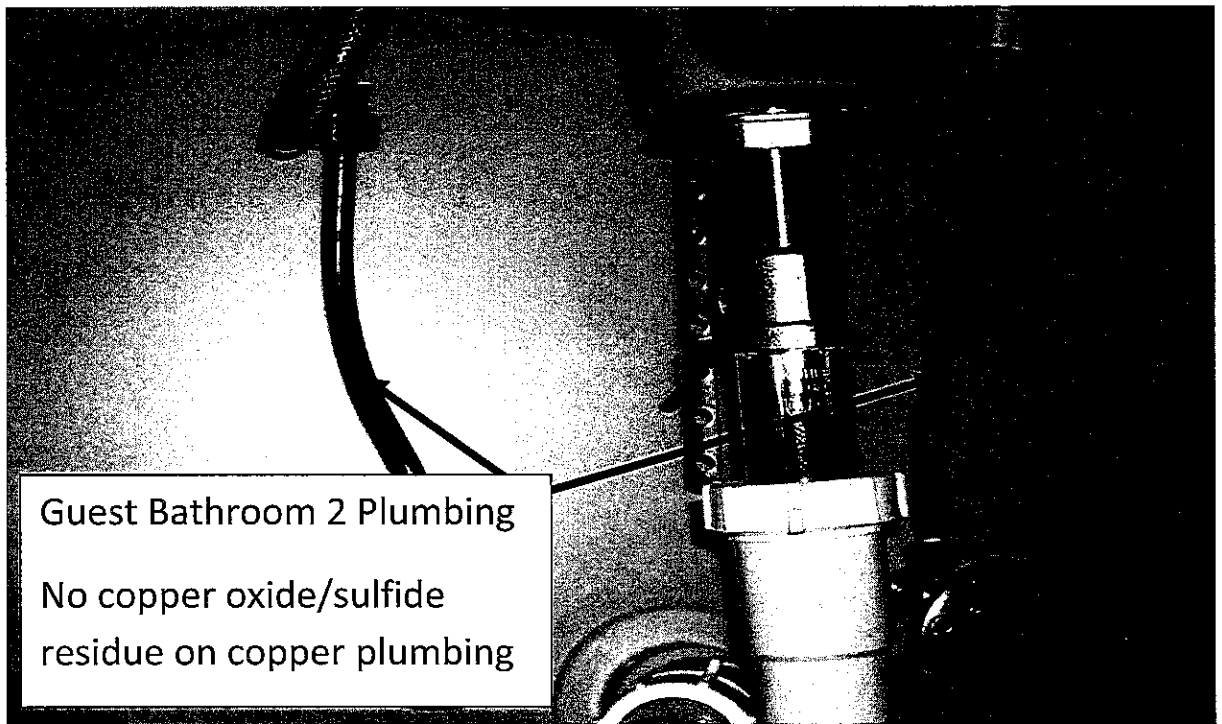
Guest Bathroom 2 Plumbing  
No copper oxide/sulfide residue on copper plumbing

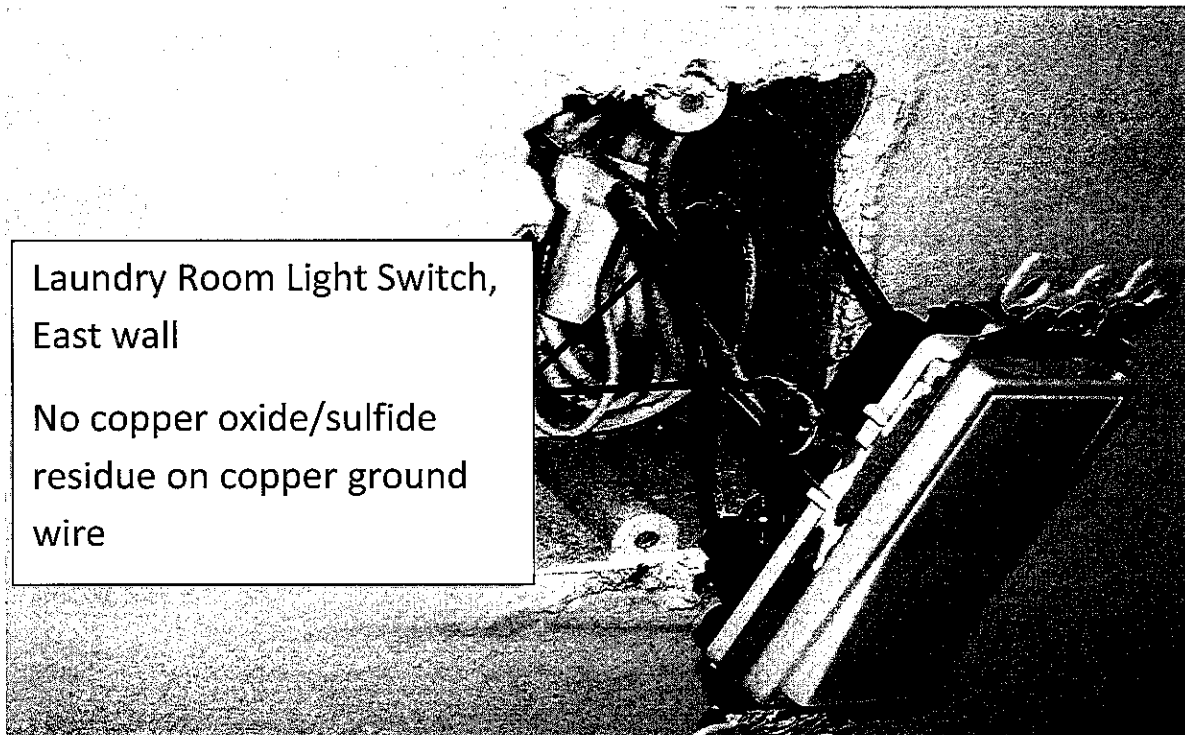
Laundry Room Light Switch,  
East wall

No copper oxide/sulfide  
residue on copper ground  
wire

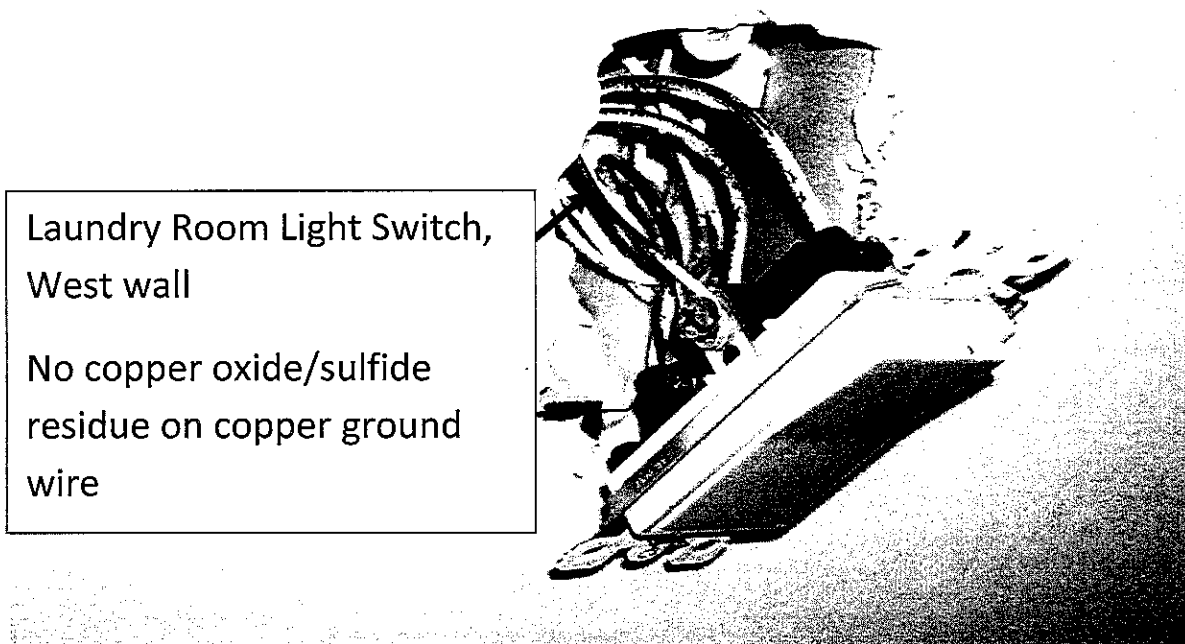
Laundry Room Light Switch,  
West wall

No copper oxide/sulfide  
residue on copper ground  
wire
