Property Screening Report

6595 Martinique Way, Vero Beach, FL 32967

FL01-0188

RE: Chinese Drywall Screening Report Number FL07-0252
Property located at: 6595 Martinique Way, Vero Beach, FL 32967

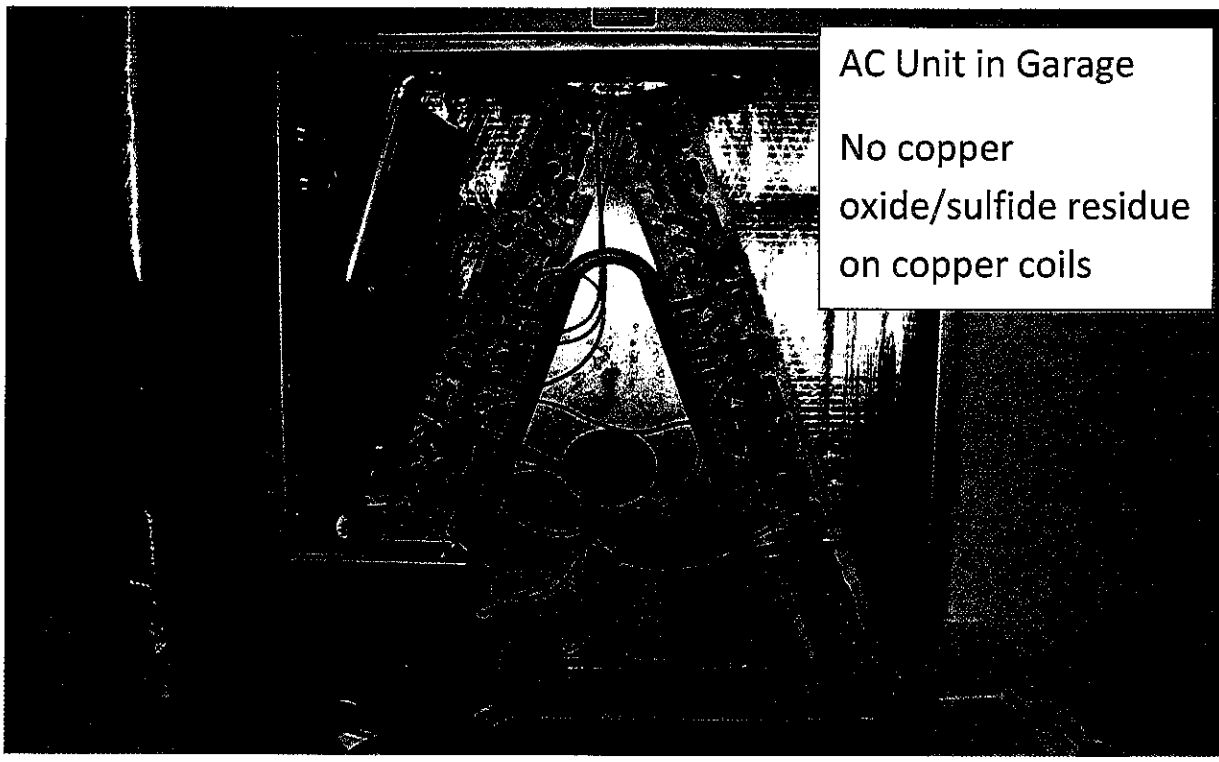
AC Unit in Garage
No copper
oxide/sulfide residue
on copper coils

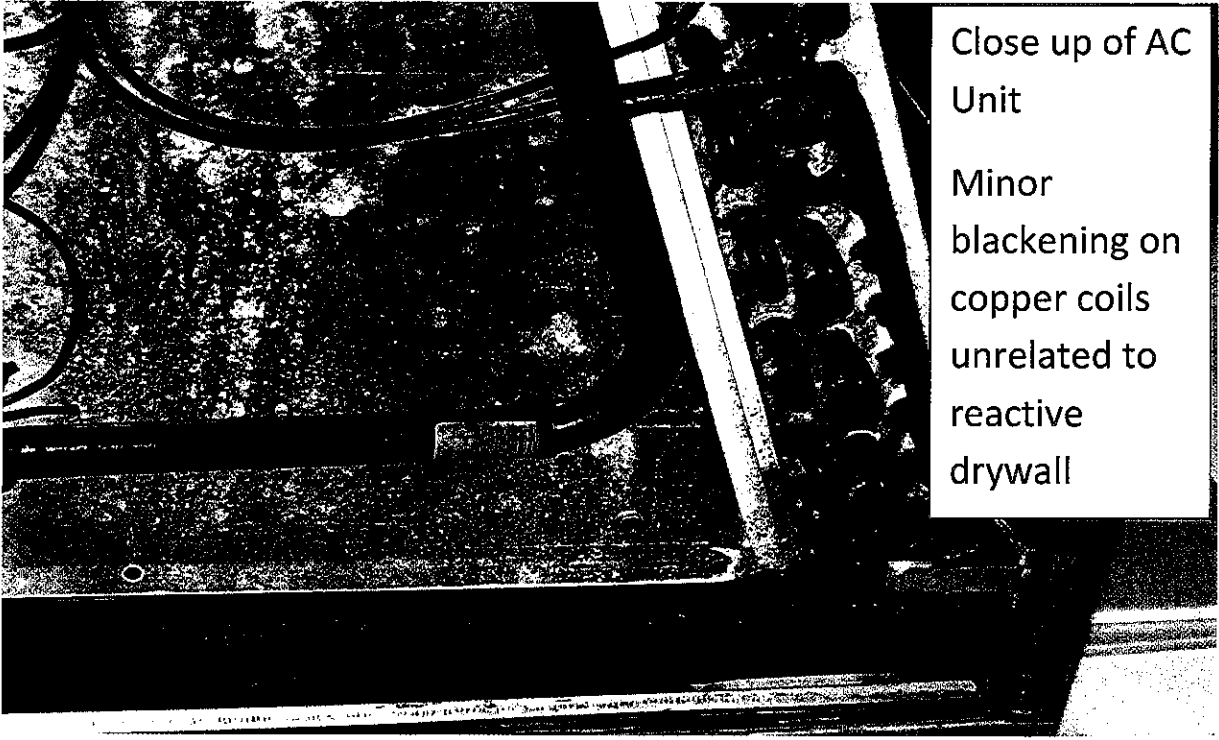
Close up of AC
Unit
Minor
blackening on
copper coils
unrelated to
reactive
drywall

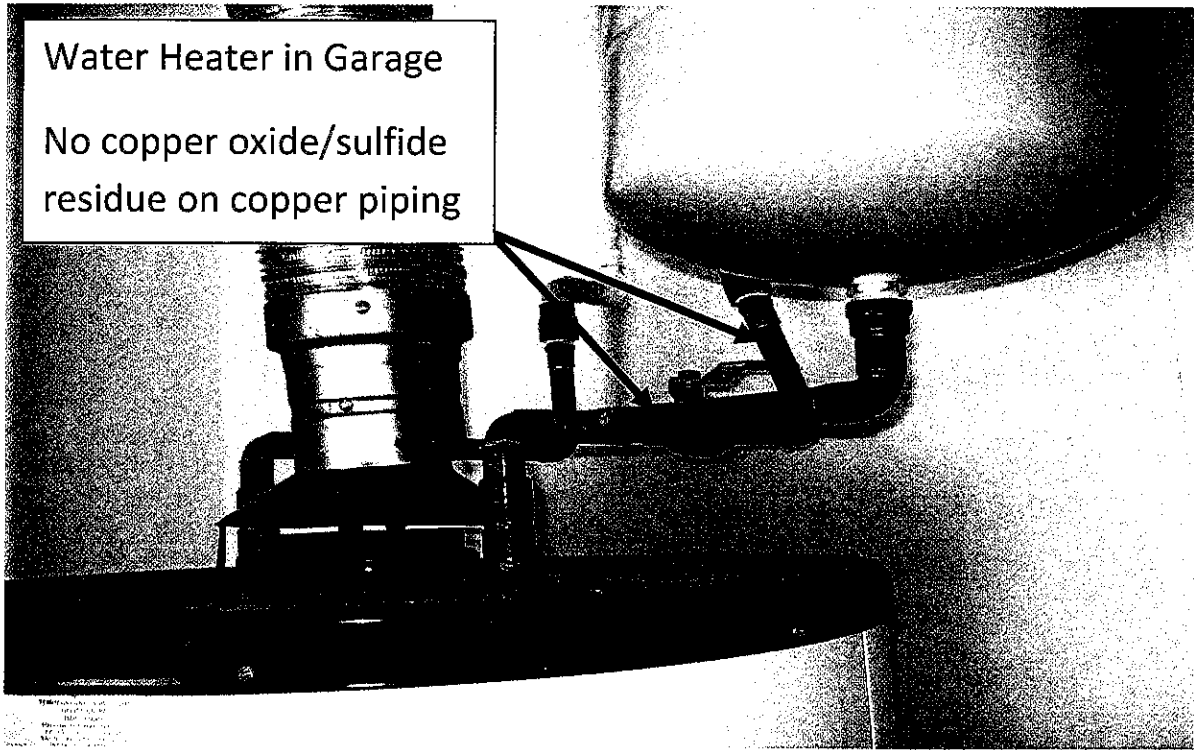
Water Heater in Garage
No copper oxide/sulfide
residue on copper piping

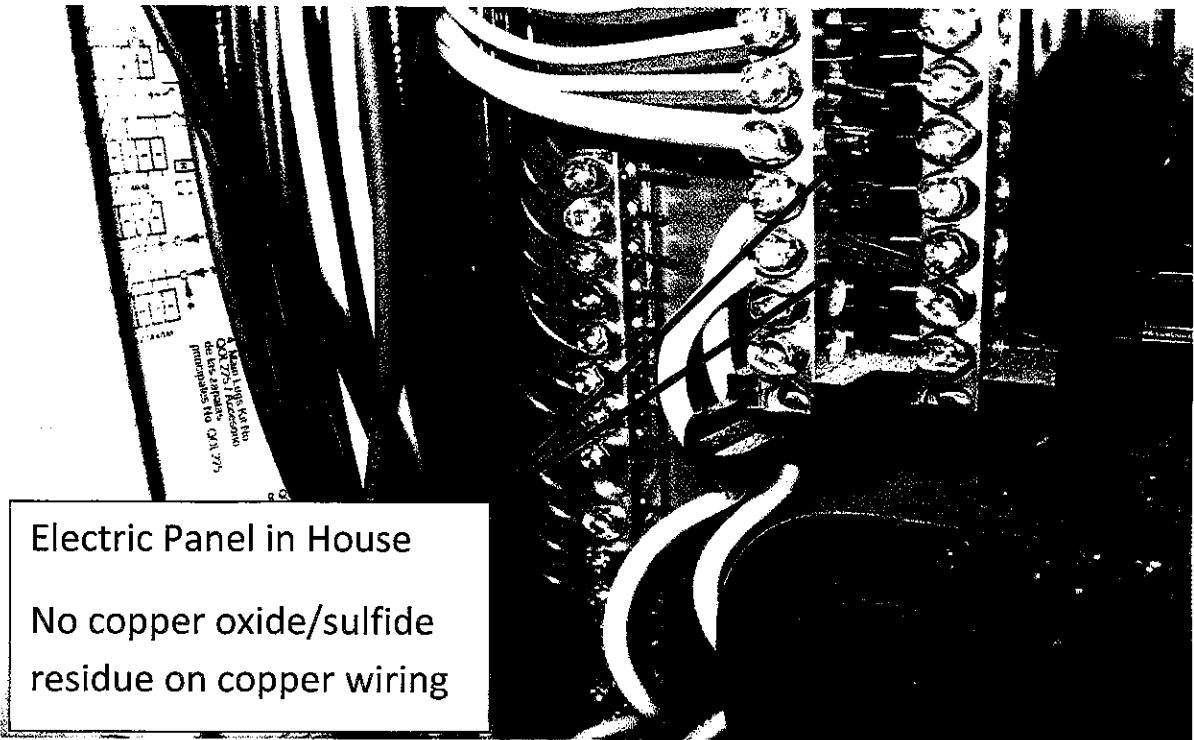
Electric Panel in House
No copper oxide/sulfide
residue on copper wiring

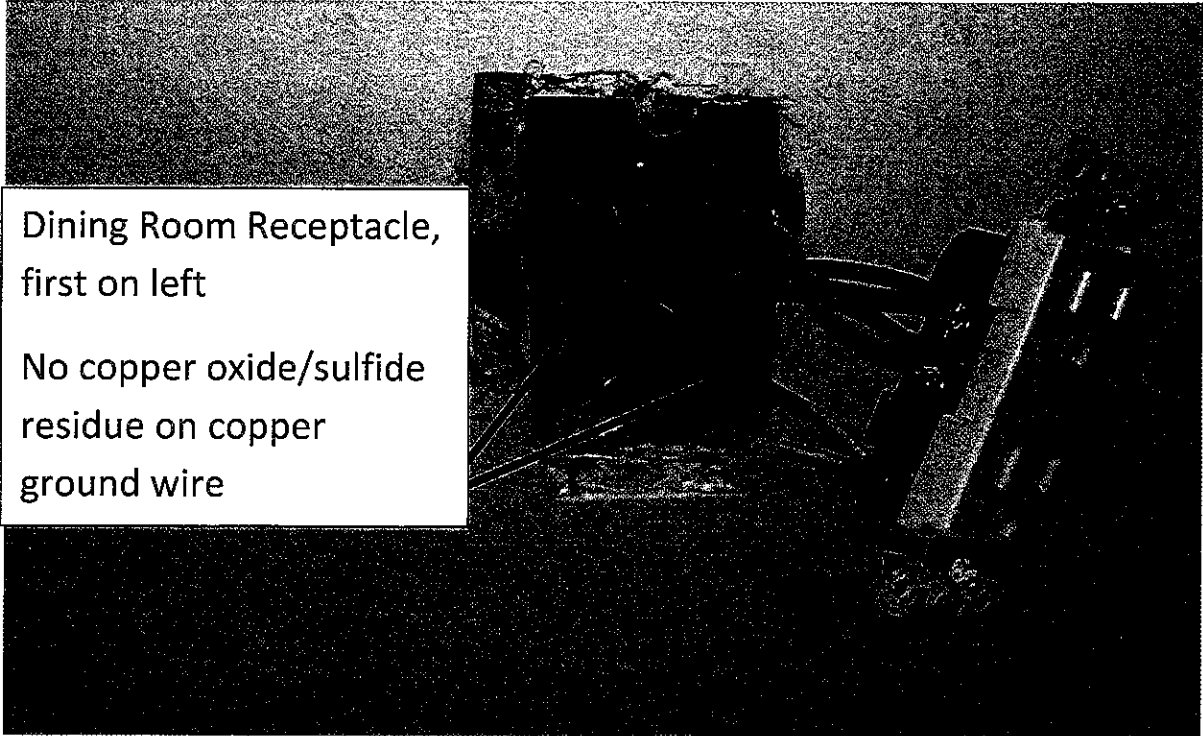
Dining Room Receptacle,
first on left

No copper oxide/sulfide
residue on copper
ground wire
