RE: Chinese Drywall Post Remediation Verification; Report No. FL05-0394B  
Property address: 6580 Martinique Way, Vero Beach, FL 32967

3,879 sf single family home located at 6580 Martinique Way in the Antilles Community in Vero Beach, Florida.

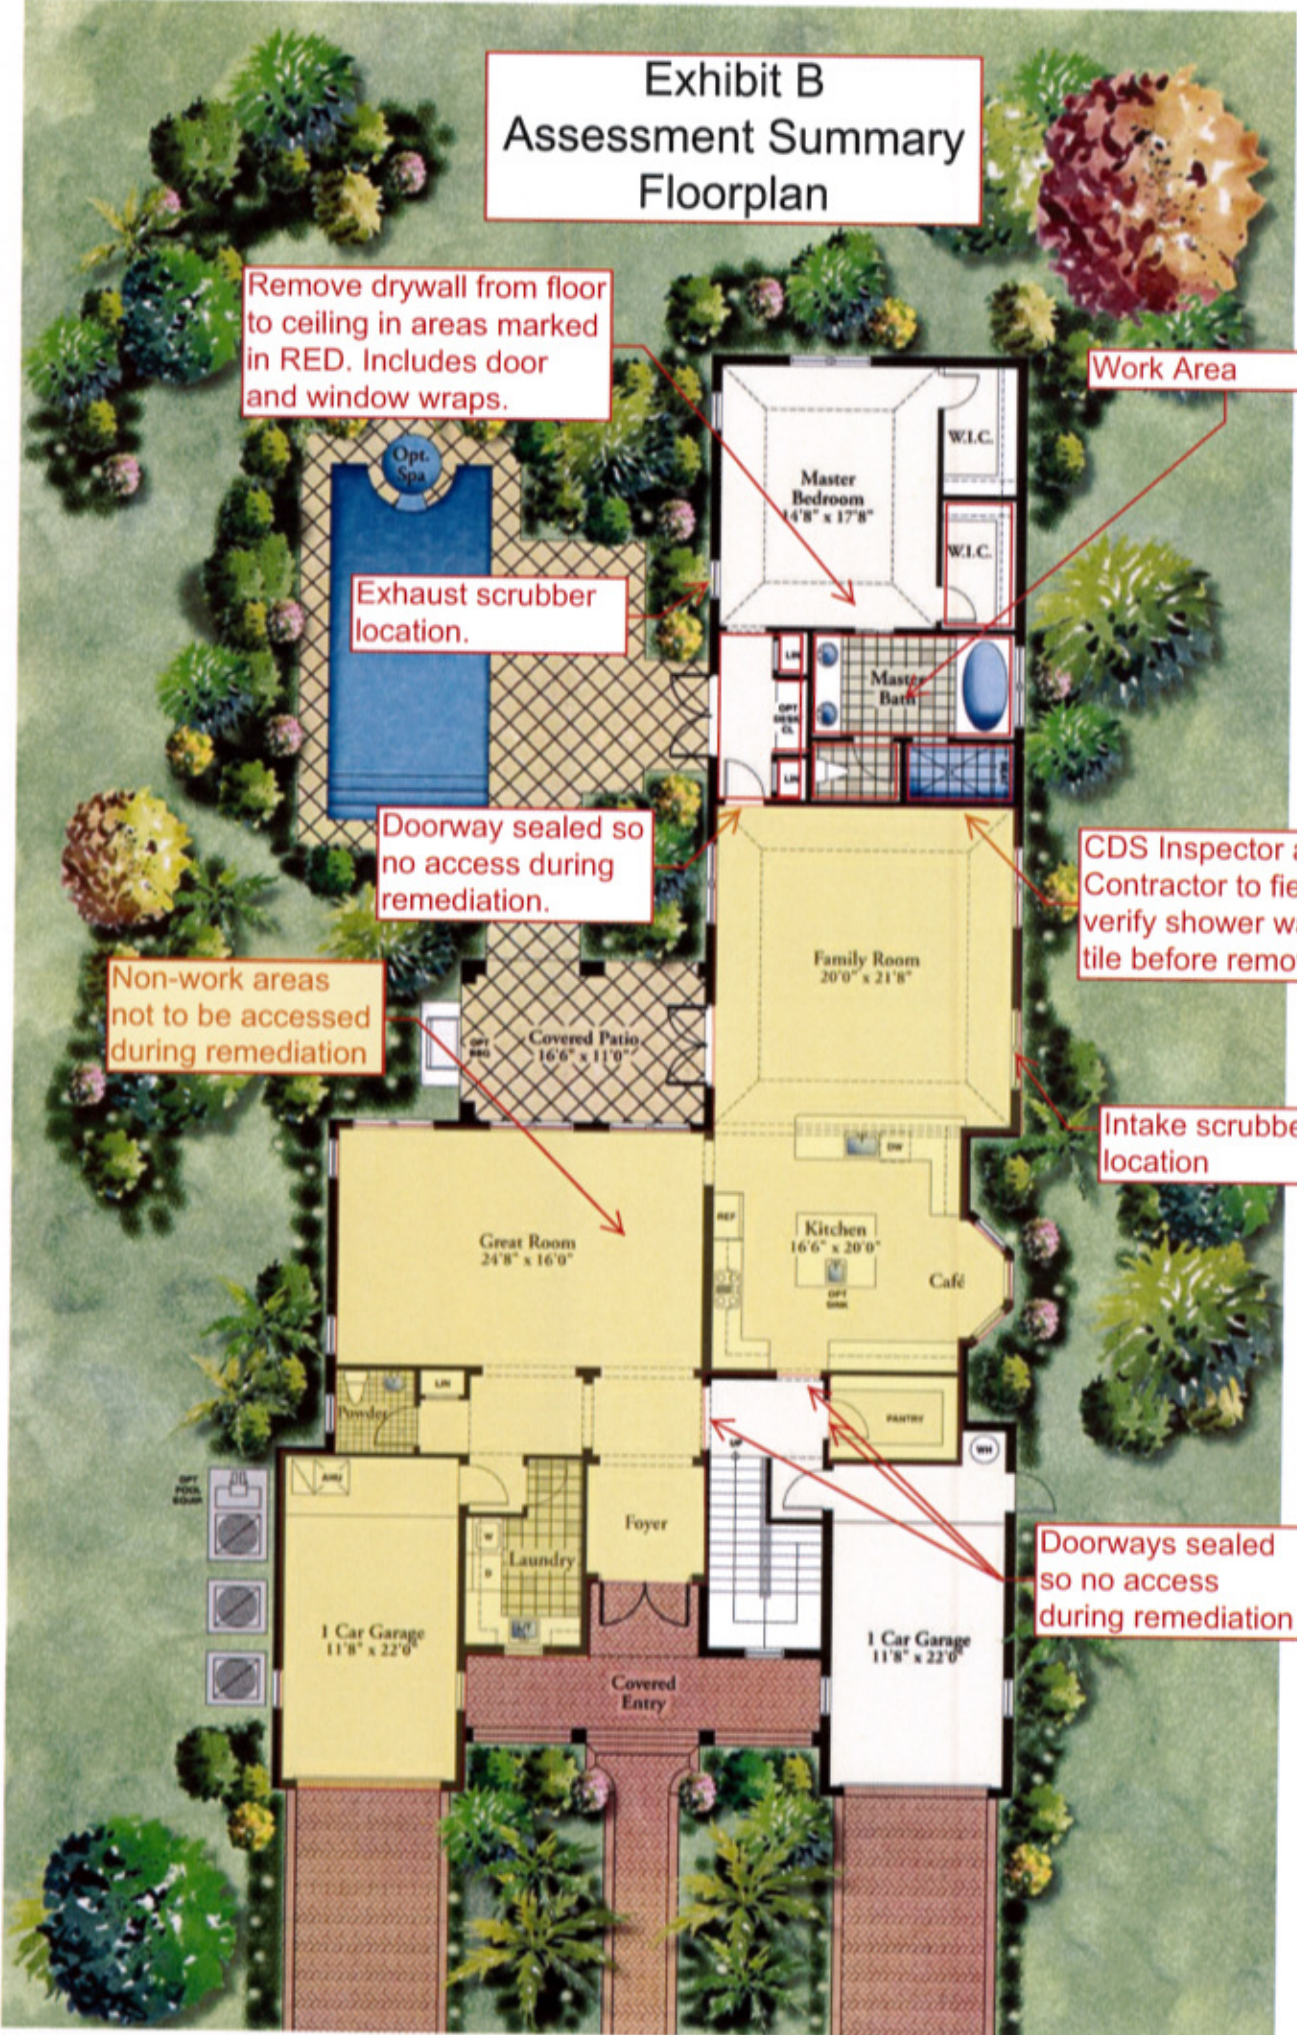
Intake scrubber location

Doorways sealed so no access during remediation

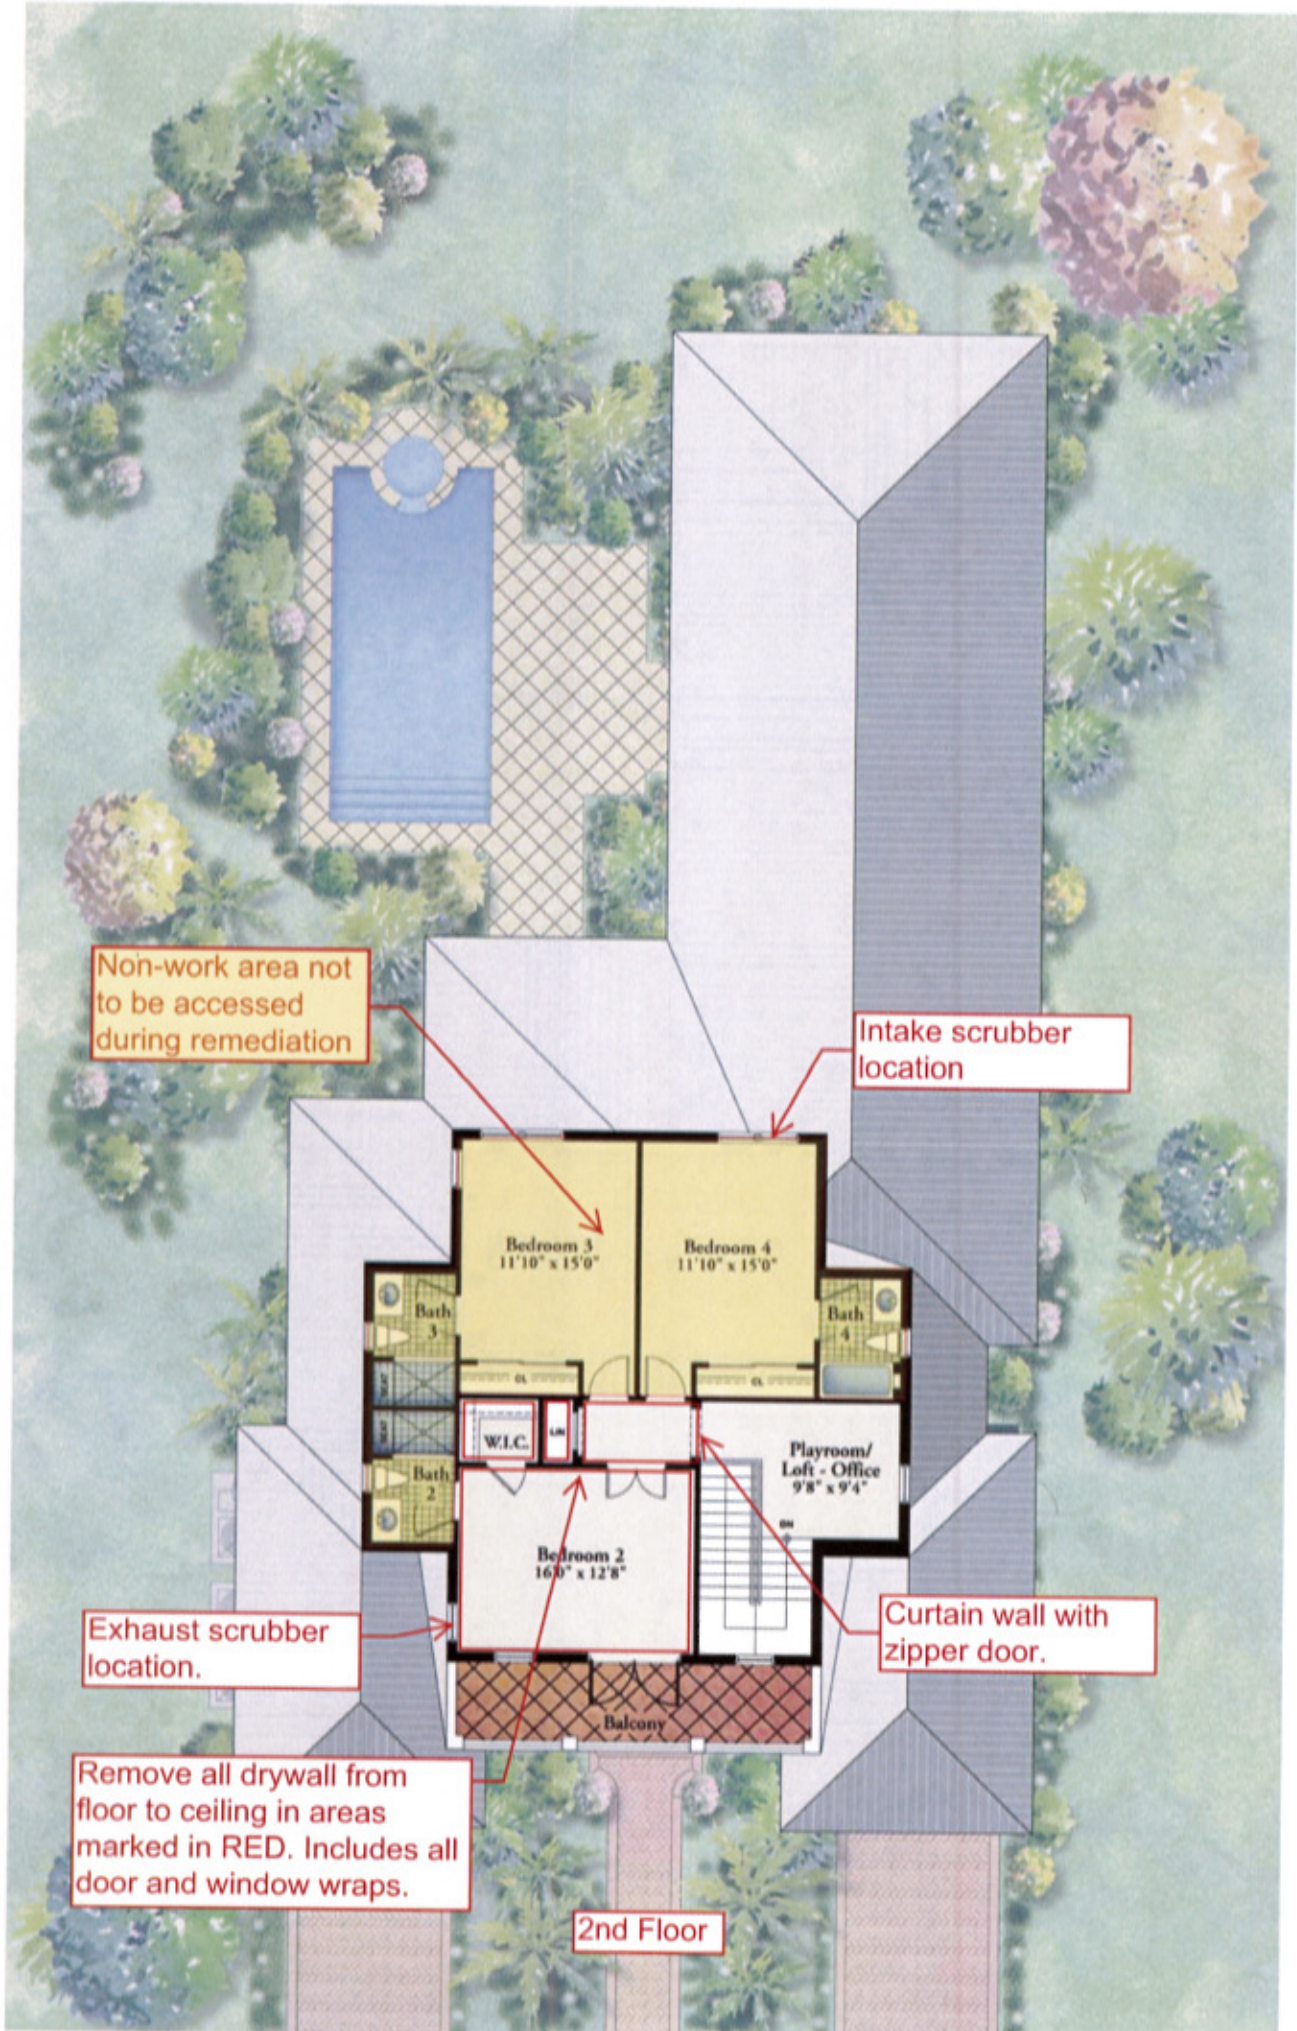
Non-work area not to be accessed during remediation

Intake scrubber location
